**Flood Control Project Maintenance  
Levee Inspections**

**Fall 2013 Levee Maintenance Deficiency Summary Report**

**Levee Inspection Report By Mile - Fall 2013**

**Sutter Maintenance Yard Maintenance Area 0003**

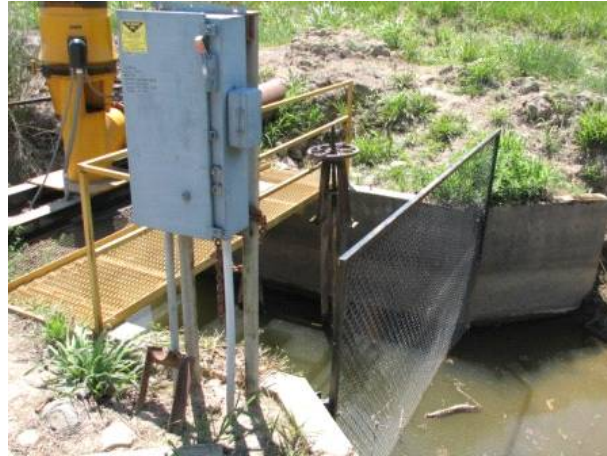
Levee Mile Report Line	4
Start Levee Mile	0.80
End Levee Mile	0.80
Location	Land Side
Category	Interior Drainage & Piping Systems
Item	Sluice / Slide Gates

Levee mile 0.80, this photo is looking at the landside toe, one of these pipes leaked during the high water event of 2010/2011. A flap gate prevents flow from the waterward side to the landward side of the levee.

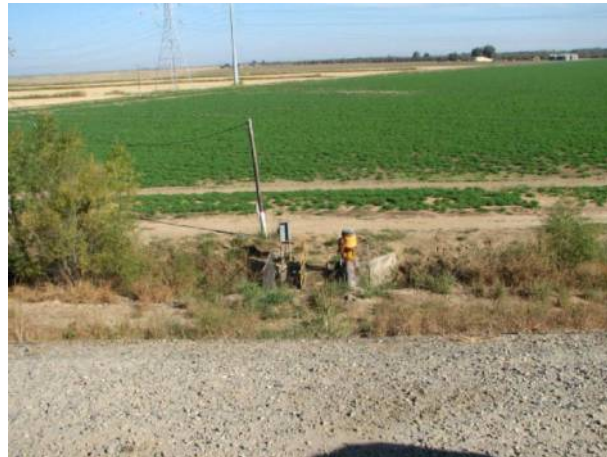
Levee Mile Report Line	12
Start Levee Mile	0.80
End Levee Mile	0.80
Location	Land Side
Category	Supplemental
Item	DWR UCIP Field Study

Concrete headwall with walkway and slide gates at LS toe.

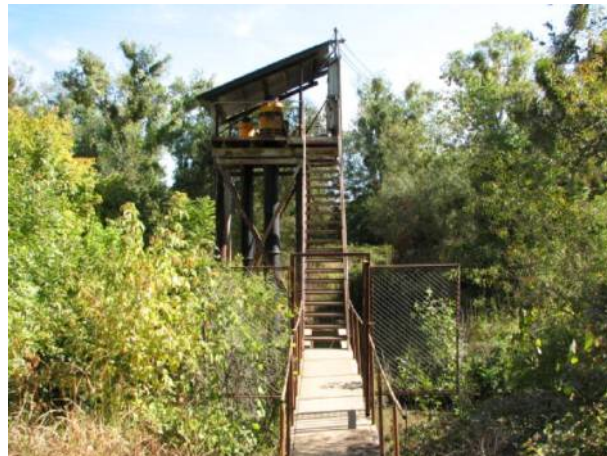
Levee Mile Report Line	15
Start Levee Mile	2.19
End Levee Mile	2.19
Location	Land Side
Category	Supplemental
Item	DWR UCIP Field Study

DWR ID: DWR_MA0003_01_f_2013_14		
16	2.19	2.19	Supplemental	DWR UCIP Field Study	WS	M En	Inspector Comments: FS_ID:13570 EP_NO: 3284 Repair Type: Non-Urgent Crossing Status: Found UCIP Comments: Pumping plant has been disconnected from levee. Need to determine if abandonment is appropriate or if this is now a gravity drain with flap gate. 5/21/2013 Pumping plant was running and filling concrete vault on WS toe through the left flap gate and then flowing through levee pipe and filling irrigation ditch on LS. Left and middle flap gates appear to be connected to pumps and right gate appears abandoned. Recommend contacting owner to get more details. FIELD_STRUCT_DESC: 32-inch by 32-inch concrete box culvert through the levee approximately 28 feet below the crown. Transition between vault on RS and box culvert within levee section is made with a 41-inch CMP. Slide gate on LS at concrete headwall. Flap Gate in concrete vault on RS at terminal of pipes from pump structure in floodway. Pipes from pump station in creek be no longer connected. (Permit No. 3284) FS Date: 5/21/2013 2:33:53 PM	38.911734 ° 38.911734 °	-121.586106 ° -121.586106 °	15

Pumping plant on WS toe at small slough. Pipes no longer connected to concrete box on WS toe.

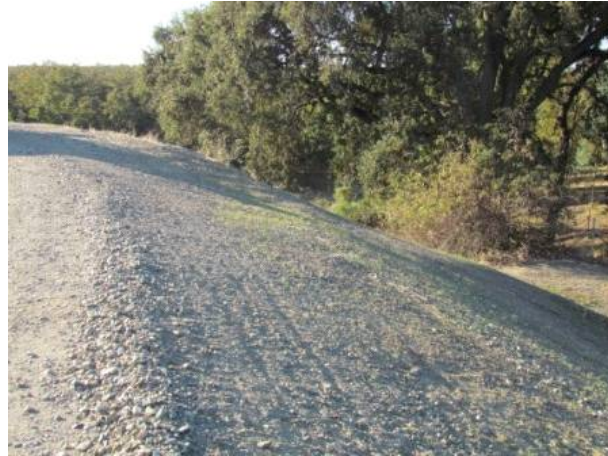
Levee Mile Report Line	18
Start Levee Mile	3.64
End Levee Mile	3.64
Location	Land Side
Category	Earthen Levee
Item	Vegetation

LMR No.	Levee Mile		Category	Item	Location *	Rating ** +	Action/Comment	GPS Latitude/Longitude		Issue No. Photo
	Start	End						Start	End	
18	3.64	3.64	Earthen Levee	Vegetation	LS	M Ma	V4 : Elderberries are blocking visibility and flood fight capability. Inspector Comments: Elderberries on the landward levee toe.	38.930063 ° -121.590211 °	38.930063 ° -121.590211 °	19 Y
DWR ID: DWR_MA0003_01_f_2013_19										
19	5.18	5.18	Earthen Levee	Vegetation	WS	A Ma	V1 : Control annual grass and weeds on the levee slopes and easements.	38.950930 ° -121.585773 °	38.950930 ° -121.585773 °	18
DWR ID: DWR_MA0003_01_f_2013_18

This photo was taken from the levee crown facing south looking down the landward levee slope at a group of Elderberries. Fall 2013.
